CRACKS IN THE WING by Fred Keip

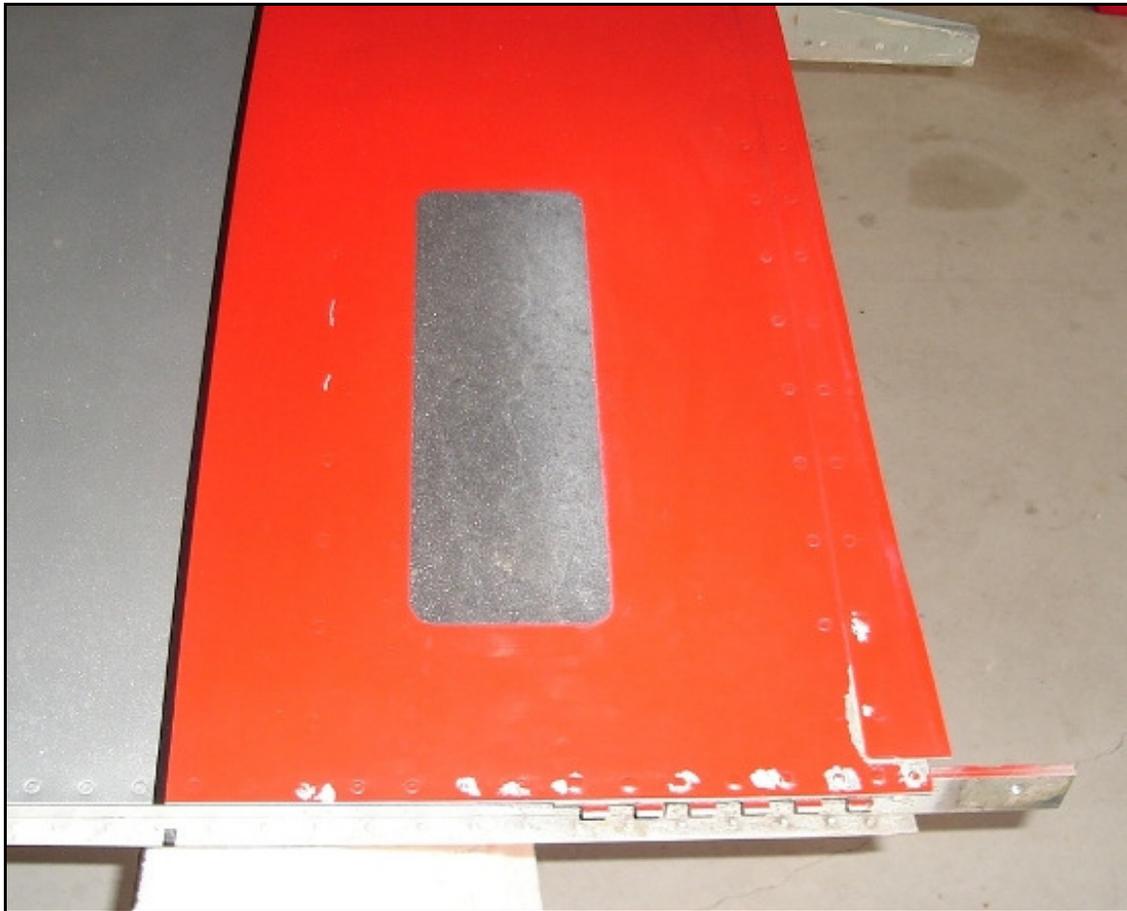
So, I guess I wasn't too surprised (a little disappointed, perhaps, but not surprised) to find a couple small fatigue cracks in the left wing skin just outboard of the wing walk area. They actually showed up as two small cracks in the Superflight polyurethane paint next to two of the rivets that attach the upper inboard skin to the #2 wing rib. The interesting thing was that the cracks did go thru the rivet holes, but followed around the edge of the dimple. Now, I wasn't overly concerned about the structural integrity of the wing, but I wanted to know the cause, and if there was any underlying damage to the #2 rib.

The cracks are just to the left of the wing walk pad at the 5th and 6th rivets from the rear spar. The paint was removed to show the cracks. The paint removed at the rear spar rivets is due to some corrosion that was under the paint.

The final step was to stop-drill the three cracks in the wing skin. I did this by carefully chipping away the paint around the three cracks, and lightly sanding the area to determine where the ends of the crack were. The ends were then punched with an automatic center punch, and then drilled with a 3/32" drill bit.

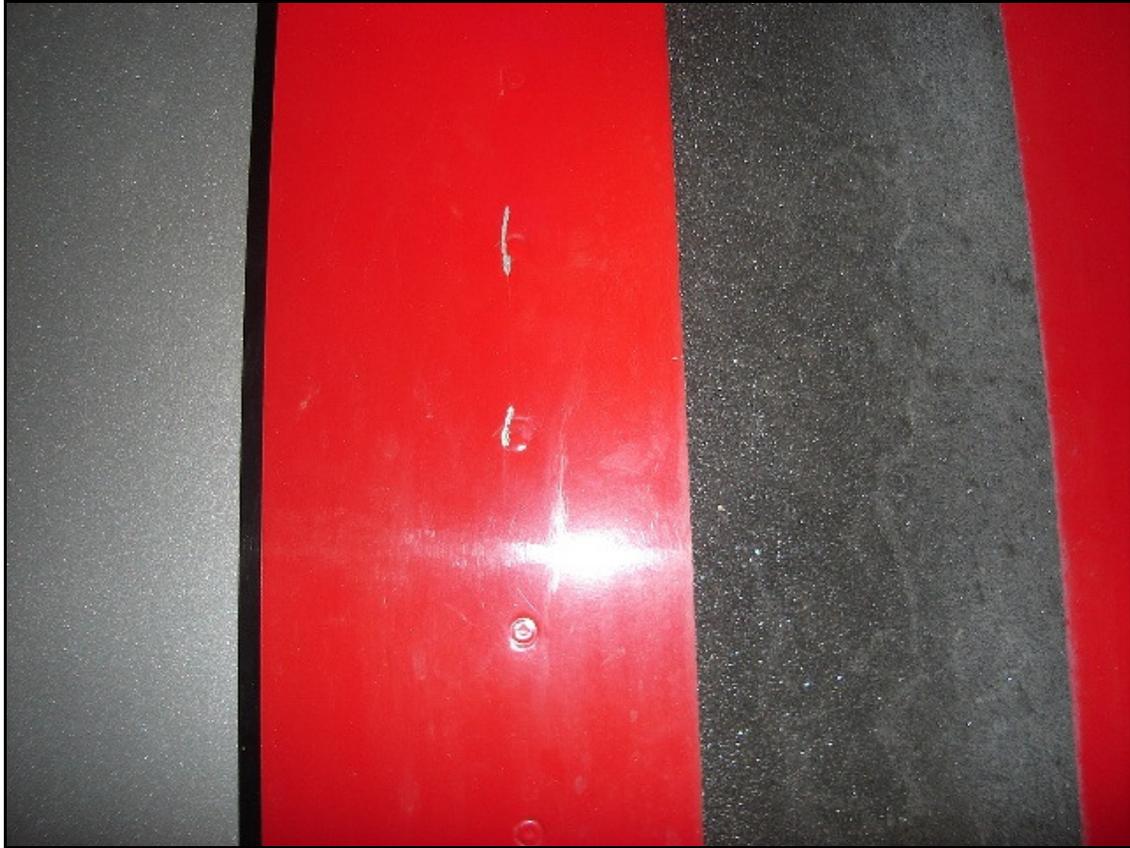
A close-up of the skin cracks. If you look closely, you can see a third crack at the top rivet.

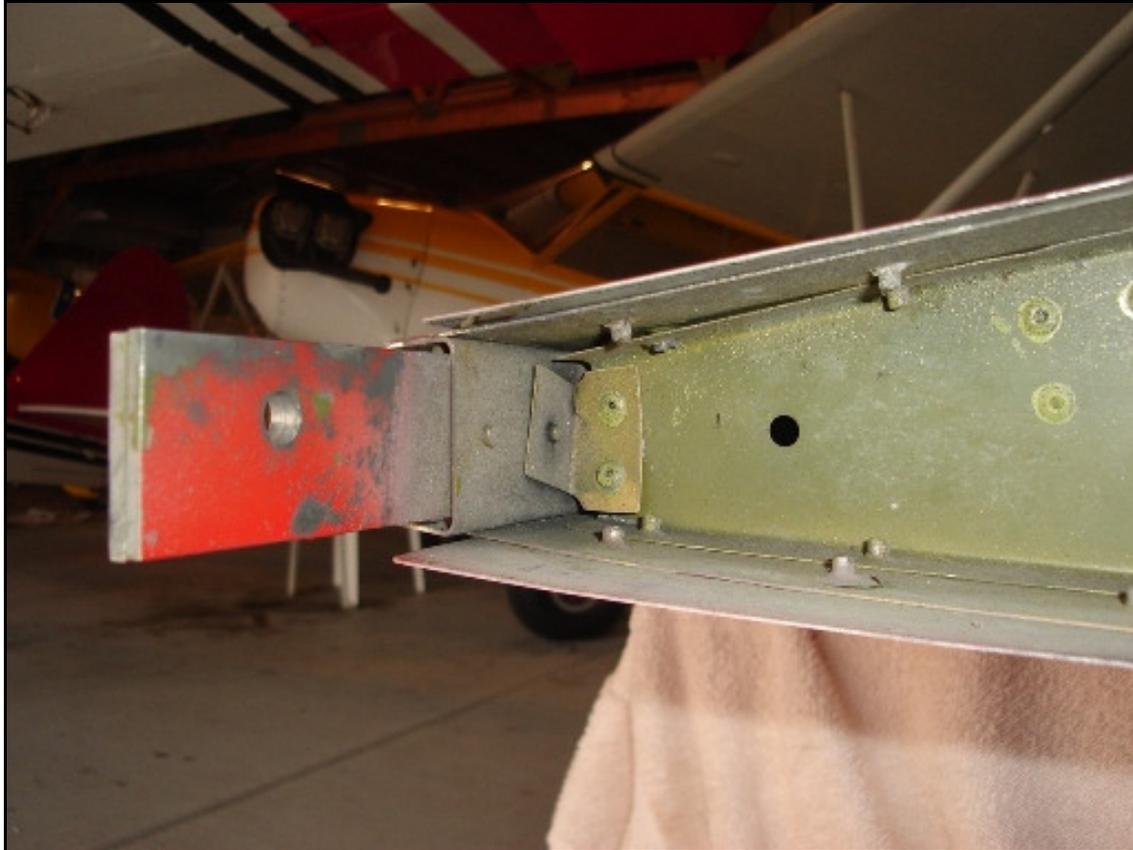
So, with a little help from a friend, I pulled the three LH taper pins, pulled the wing, and set it on a pair of saw horses. What I found right off the bat was that the fitting that attaches the root rib to the rear spar was cracked, twisted, and one of the rivets that attached it to the rib was pulled thru the rib. Also, the rearmost top skin rivet in the root rib had pulled thru the top flange of the rib. Inspection of the #2 rib showed no cracks in the rib flange under the skin cracks, nor at the attachment to the rear spar. And there were no cracks or distortion of the wing walk structure.

The failed root rib attach bracket. Note that the top rear rivet has pulled thru the rib.

The one thing I didn't adequately consider when designing the walk was how the loads would get transferred into the rear spar, and that was the cause of this problem. The wing ribs are attached to the rear spar with a single rivet in each rib. What happened in this case is that when I stepped up on the wing, the rib would push down on the attach bracket, and since the rivet was offset from the center of the rib, the rib tried to rotate around the rivet. At some point the fitting cracked allowing the rib to move downward. Because the rib moved downward, the top wing skin was forced to bend over the #2 rib. And the cracks were the result.

The fix turned out to be fairly simple, and didn't require a lot of wing disassembly to install. I decided to do three things: 1) install a new root rib attach bracket that was stronger and picked up two rivets in the rear spar to prevent it from rotating, 2) replace the rear top rivet securing the skin to the root rib, and 3) stop-drill the fatigue cracks.

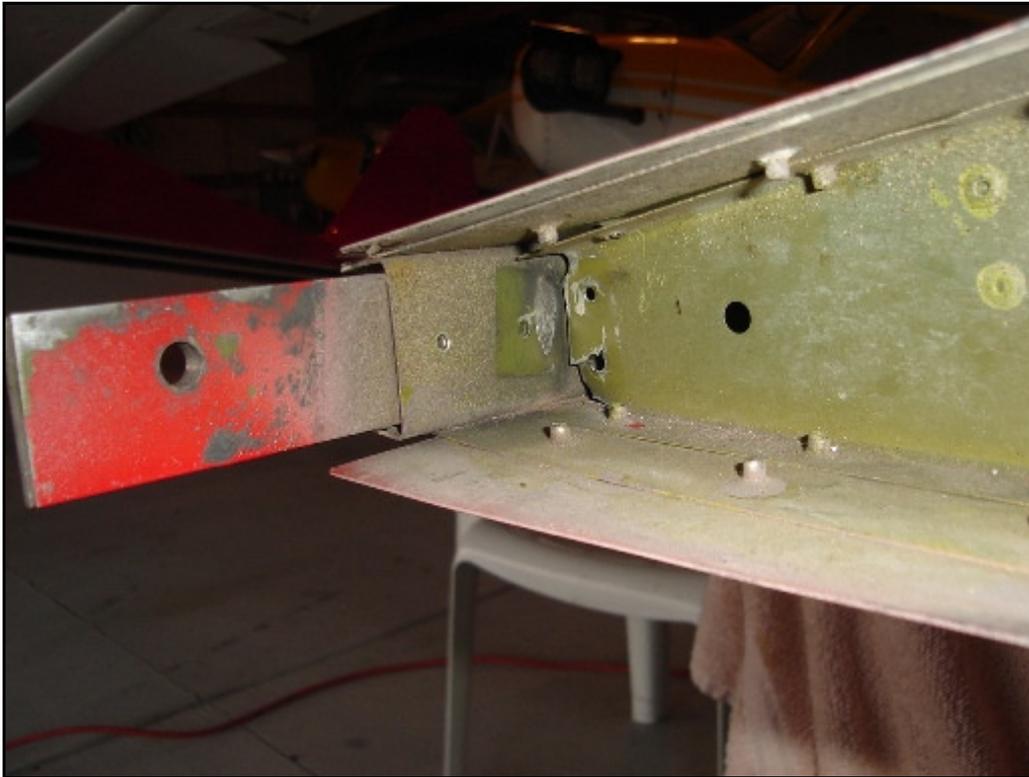
With the original bracket removed.

I started out by drilling out the two rivets that secured the original bracket, plus the inboard-most spar rivet.. I then fabricated the new rib rear attach bracket from 0.040" 2024-T3 alclad (actually a piece of leftover spar channel stock). The three 1/8" holes for the rib attachment rivets were predrilled. I clamped the bracket to the rear spar, and drilled the three holes in the rib using the three holes in the bracket as a guide. With the bracket clecoed to the rib, the two holes to the spar were drilled. I then riveted the

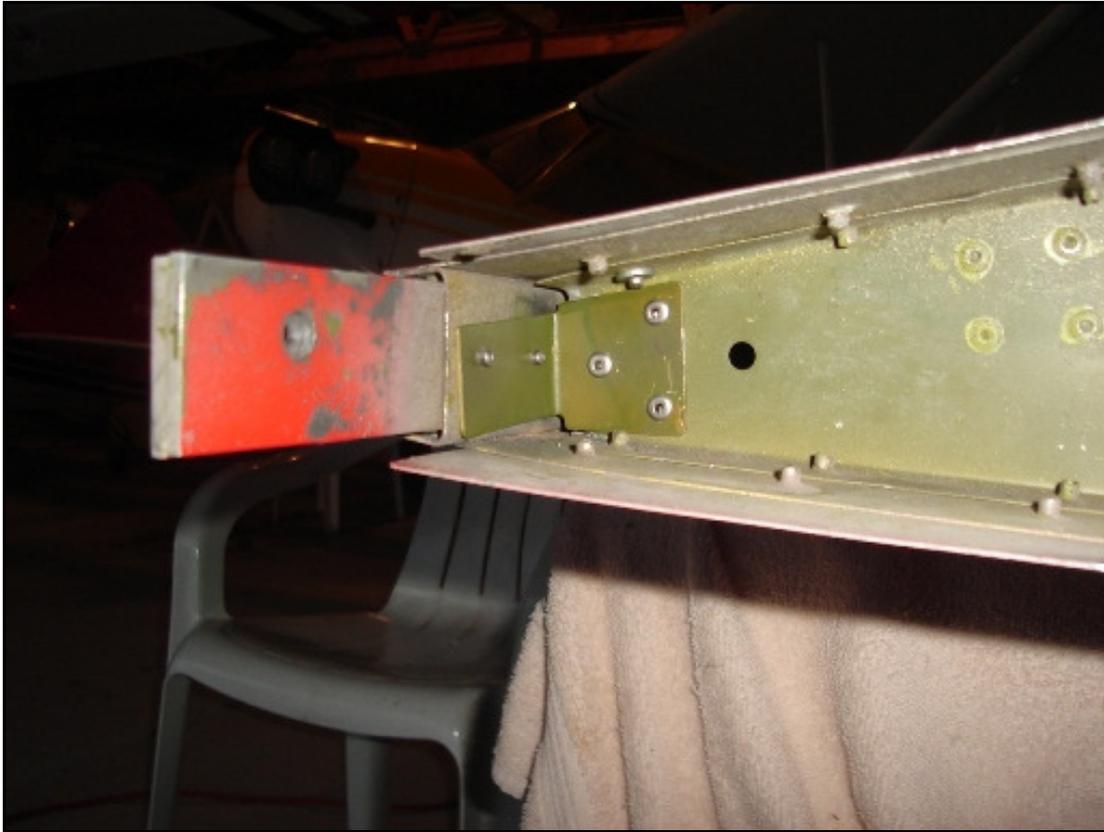
With the new bracket and top skin rivet installed

bracket using three CCP-42 and two CCP-46 rivets. The top skin rivet was drilled out and replaced with a CCC-42 rivet and an 1/8" back up washer to accommodate the damaged hole in the rib.

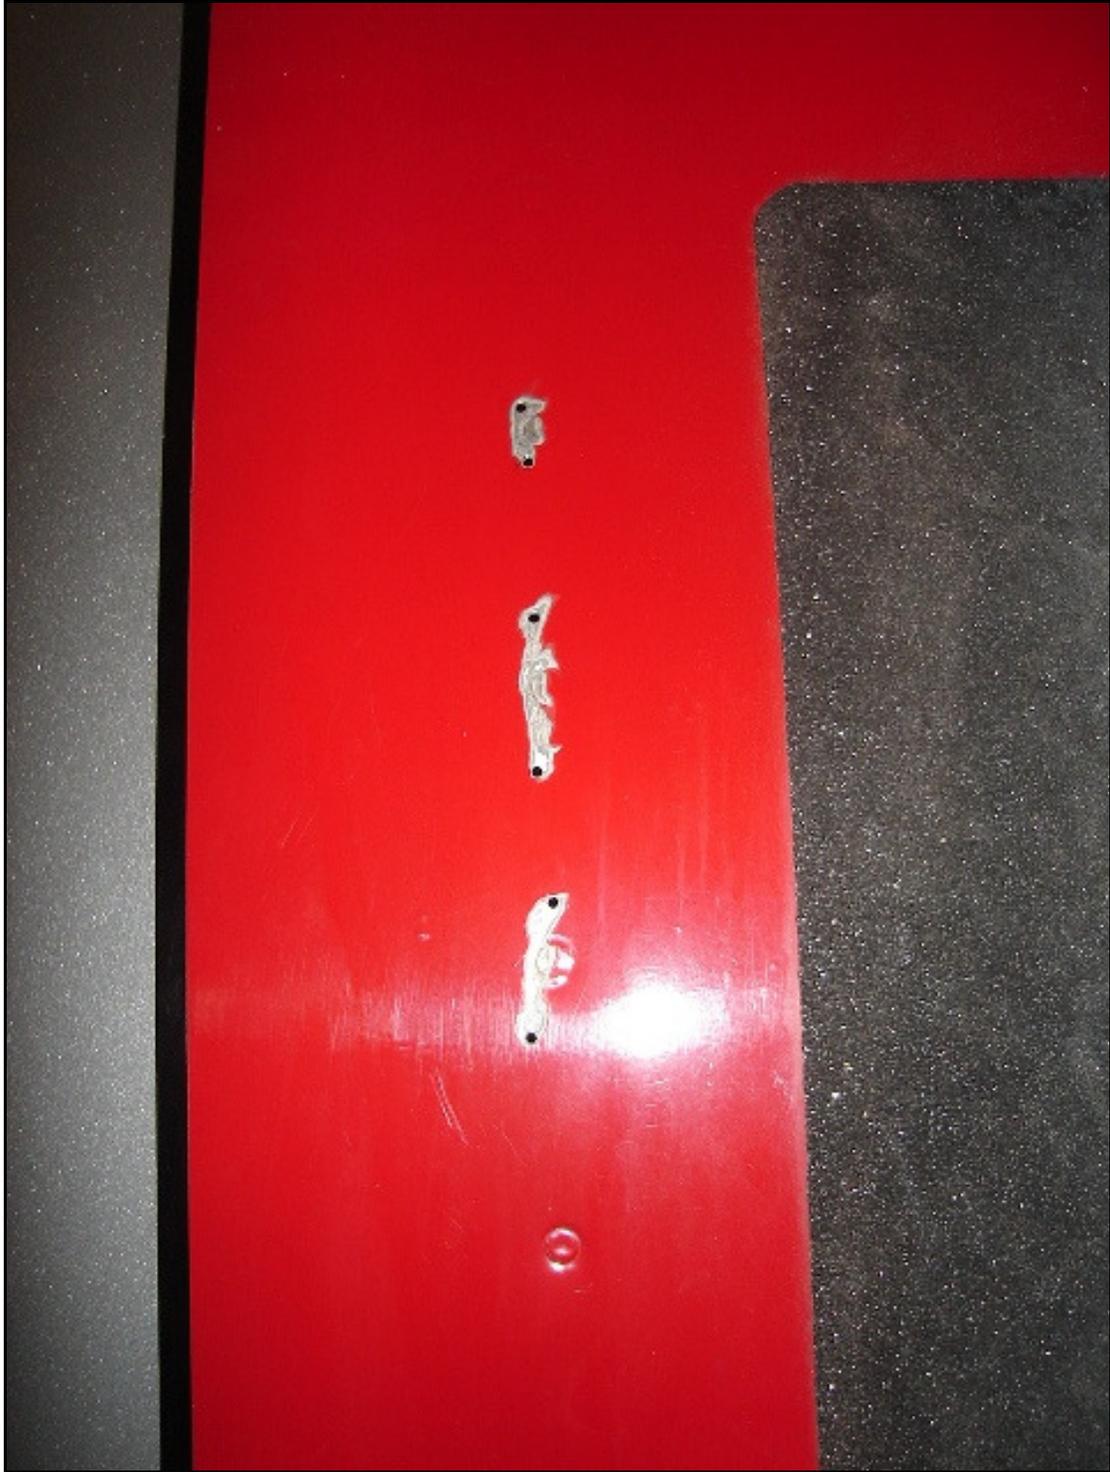
The stop-drilled cracks

To finish things off, I filled each of the holes with a dab of JB Weld to seal the holes. Once the epoxy dried, I sanded the area and applied a little touch-up paint. At the same time, the corrosion above the rear spar was cleaned, prepped, and touched up, too.
